SOIL EROSION AND SALINIZATION ON THE COAST OF THE BUGUN IRRIGATION RESERVOIR

Starodubtsev V.M., Ladyka M.M., Naumovska O.I.

Annotation. *New trends in the development of negative ecological processes on the coast of the Bugun irrigation reservoir, primarily soil erosion and salinization, are considered. The role of monitoring these processes on the basis of remote sensing data by Landsat and Sentinel satellites, as well as quadcopters, to prevent the dramatic consequences of the amplification of these processes, is noted.*

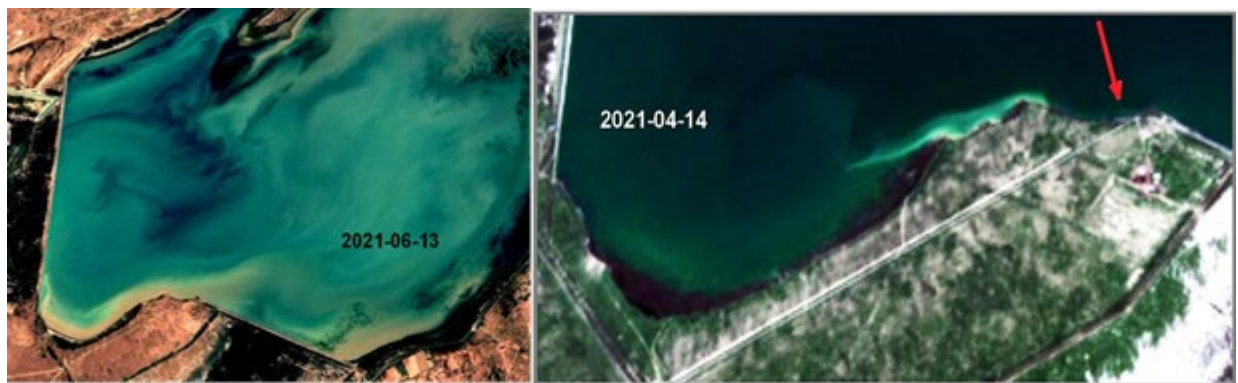
Fig Fig.3. Erosion of the south coast during strong winds (left) and the threat of outburst of the south bank of the reservoir in April 2021 (right)

Research results. The objective of this study was to verify the new trends in the development of negative processes identified in recent years [4, 6], in order to prevent their dramatic consequences. First of all, attention was paid to the increased soil erosion on the southern coast in the area adjacent to the Karazhantak dam. In our opinion, it is associated with climate change, which affected the runoff regime of the Bugun and Arys rivers, and caused a change in the timing of the reservoir filling, increased winds and a change in their direction. In the relief conditions of the foothill plain (Fig. 1), on which the Bugun reservoir was created, even at the design stage, the risk of erosion of soils and loess rocks of a low and narrow ridge, which served as the southern coast of the reservoir, was underestimated. This danger was noted by us back in the 60s [1, 2], and now it has manifested itself as a real threat of water breakthrough through the ridge and the possible destruction of the reservoir. If in the first decades the reservoir was filled in March-April, then in recent years it begins already in February, which is confirmed by the Sentinel-2 images in 2021 and 2022 (Fig. 2). At the same time, the time of influence of waves, currents and floating ice on the erosion of loess coasts is lengthened. An important factor in increasing soil erosion on the southern coast (Fig. 3, left) is an increase in the speed, frequency, and direction of winds. As a result, it is not the southwestern part of the shore of the reservoir that is eroded, as it was in the 60-80s, but the southern part. It was here that in 2021 there was an accelerated erosion of the coast and the creation of a dangerous situation threatening water overflow through the watershed and the reservoir destruction (Fig. 3, right). A quadcopter study confirmed this danger and measures were taken to prevent an emergency (Fig. 4).

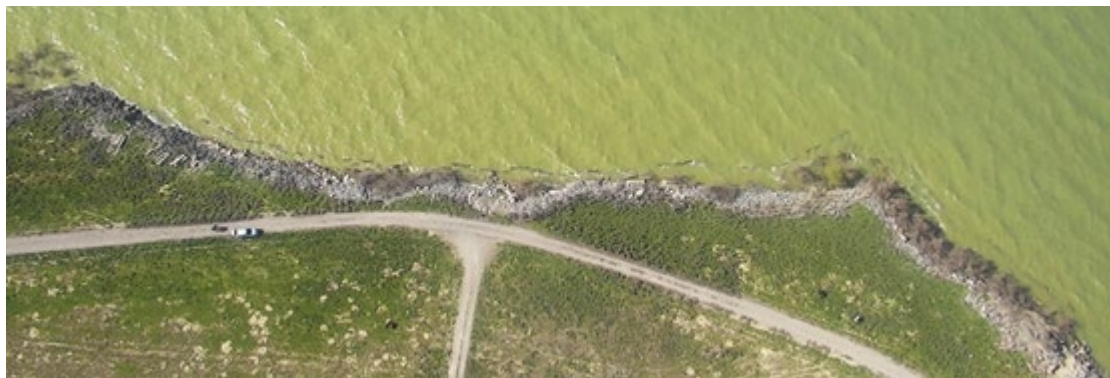
Fig.4. Erosion-prone area (drone image, 2021-04-22)

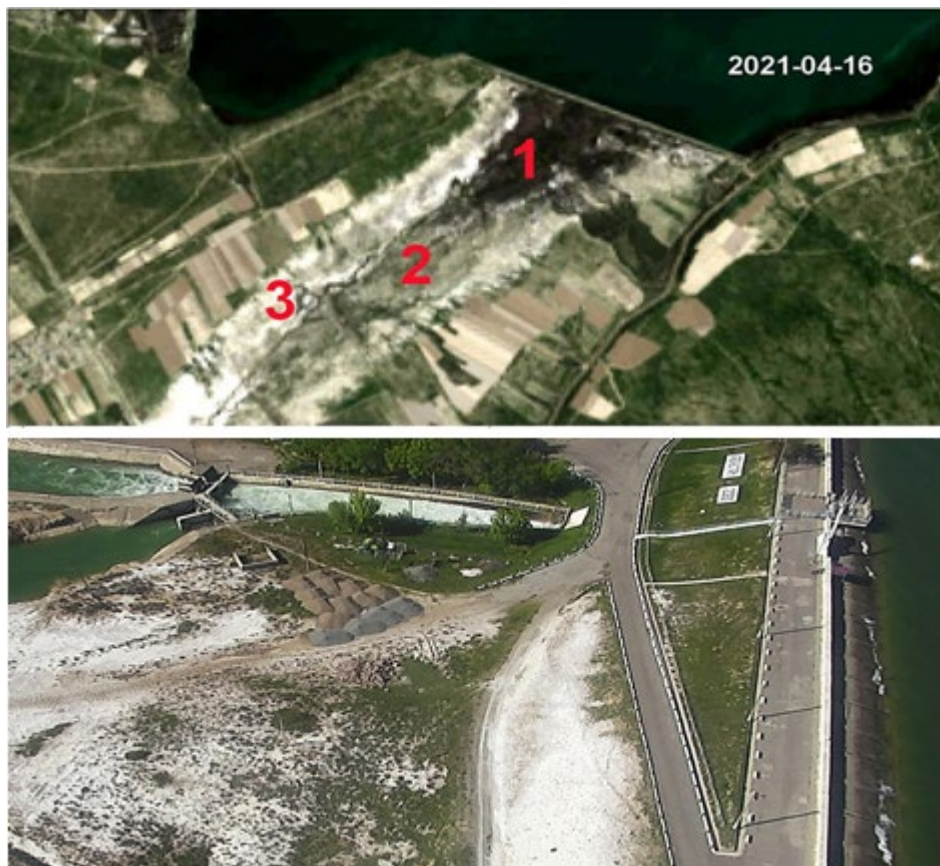
Fig. 6. Strong salinization of bog (1), meadow-bog (2) and meadow-serozem soils downstream of the Karazhantak dam (above) and the slope of the Bugun dam (below)

Soil salinization due to flooding by seepage waters downstream of the Karazhantak dam is an important negative process that is increasing on the southern coast (Fig. 6). This process was shown by us earlier [2-4], but its manifestation is becoming larger. And drone observations made it possible to identify land salinization downstream of the Bugun dam, as well as on the outer slope of the dam.
